Airport Measurements with the Traffic Speed Deflectometer

Measurement overview

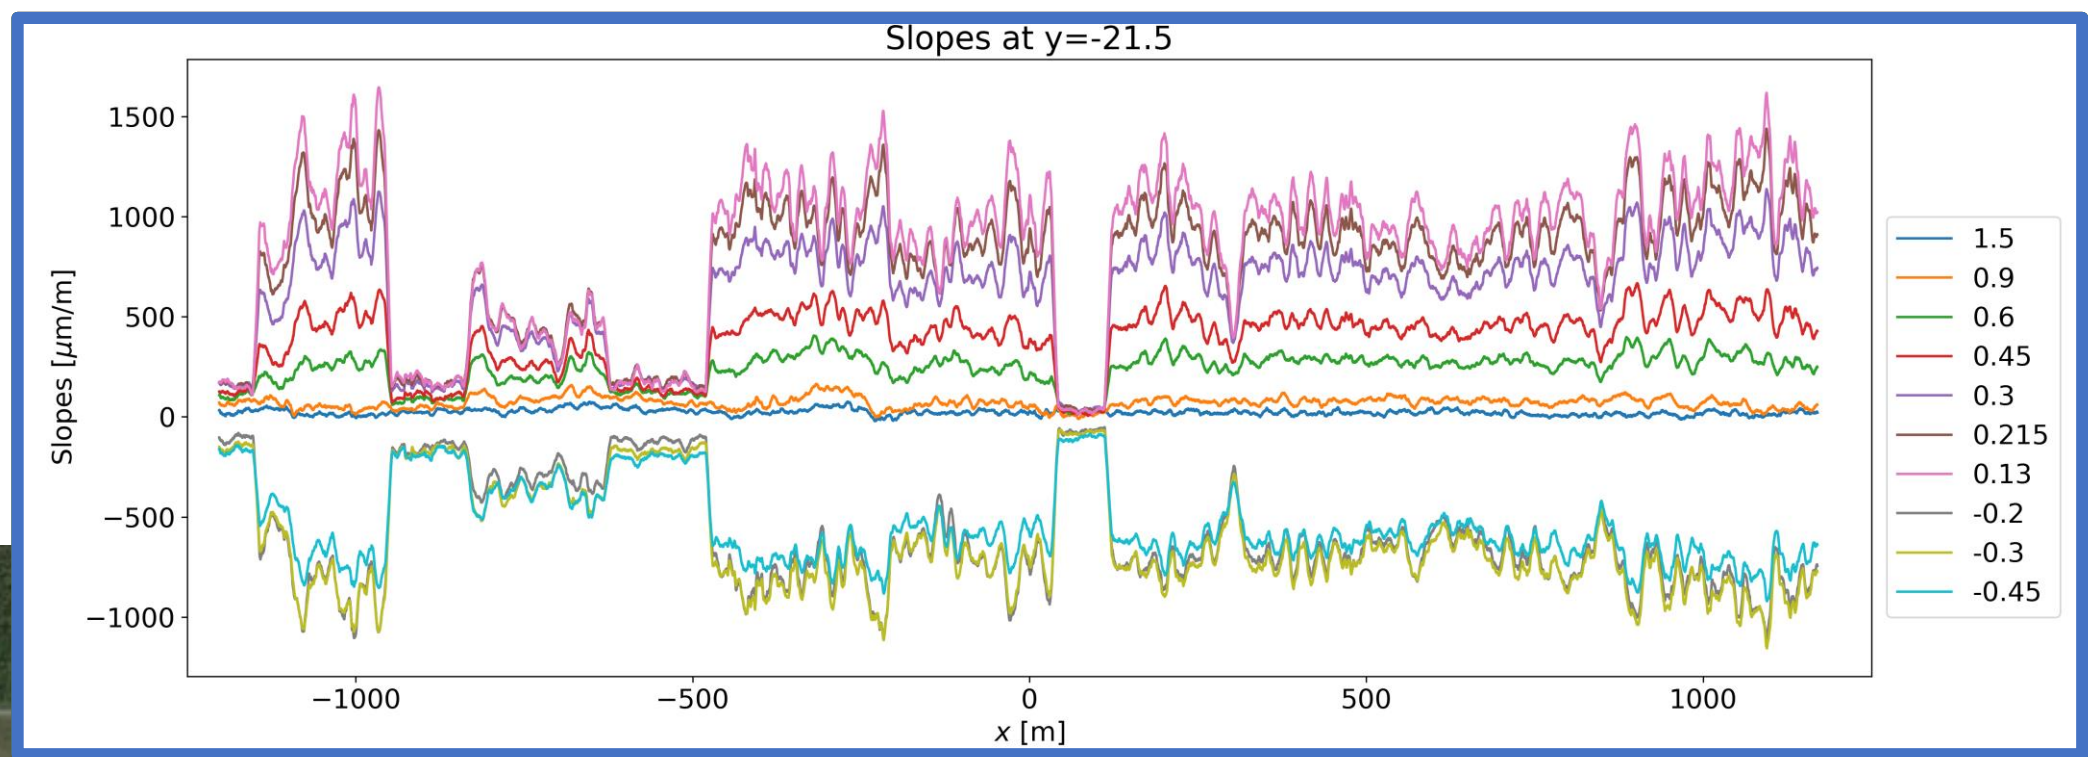
SCI300 on runway 2

2D map of pavement performance

SCI300 10m averages,
Highlight runway center

Shoulders

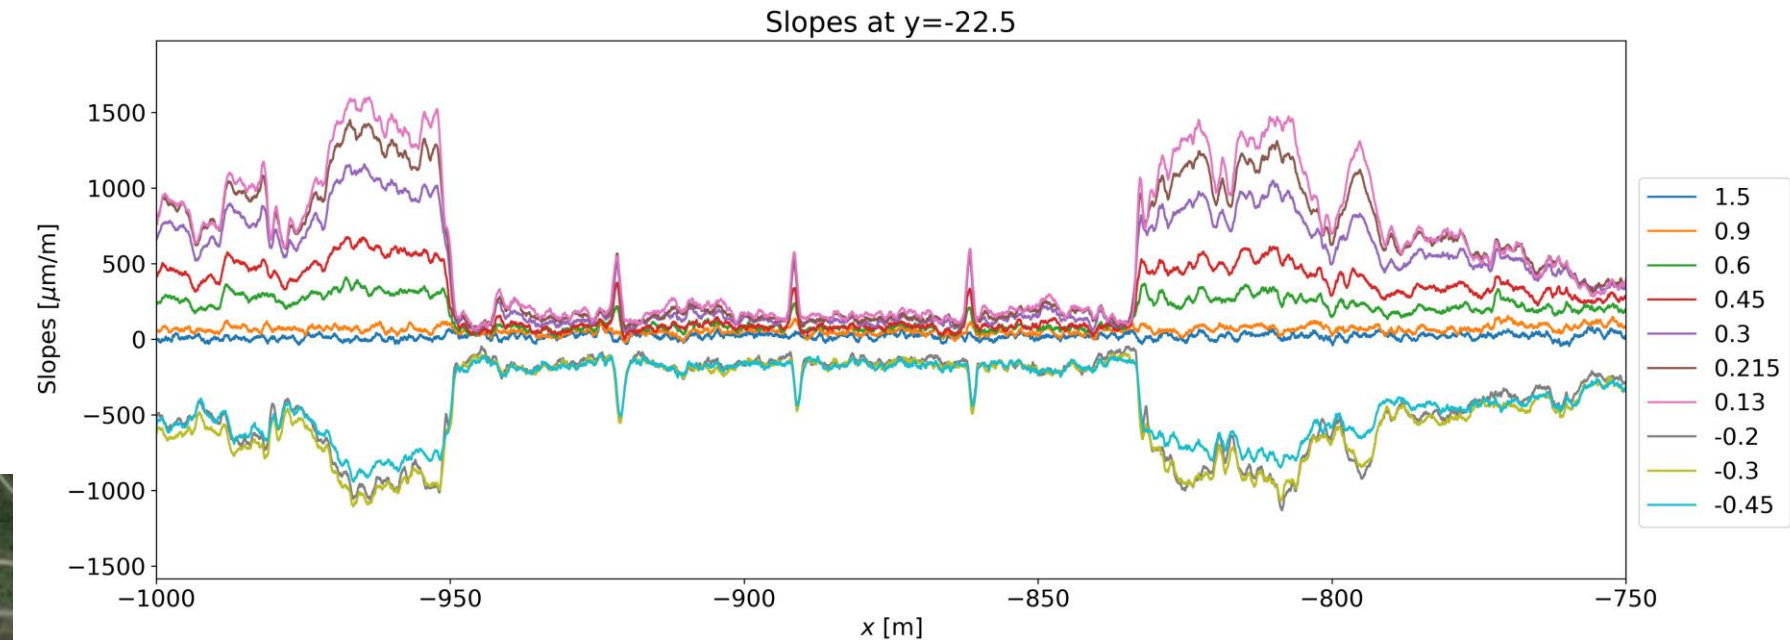
Slope in 1.5 m on runway 2

High slope band

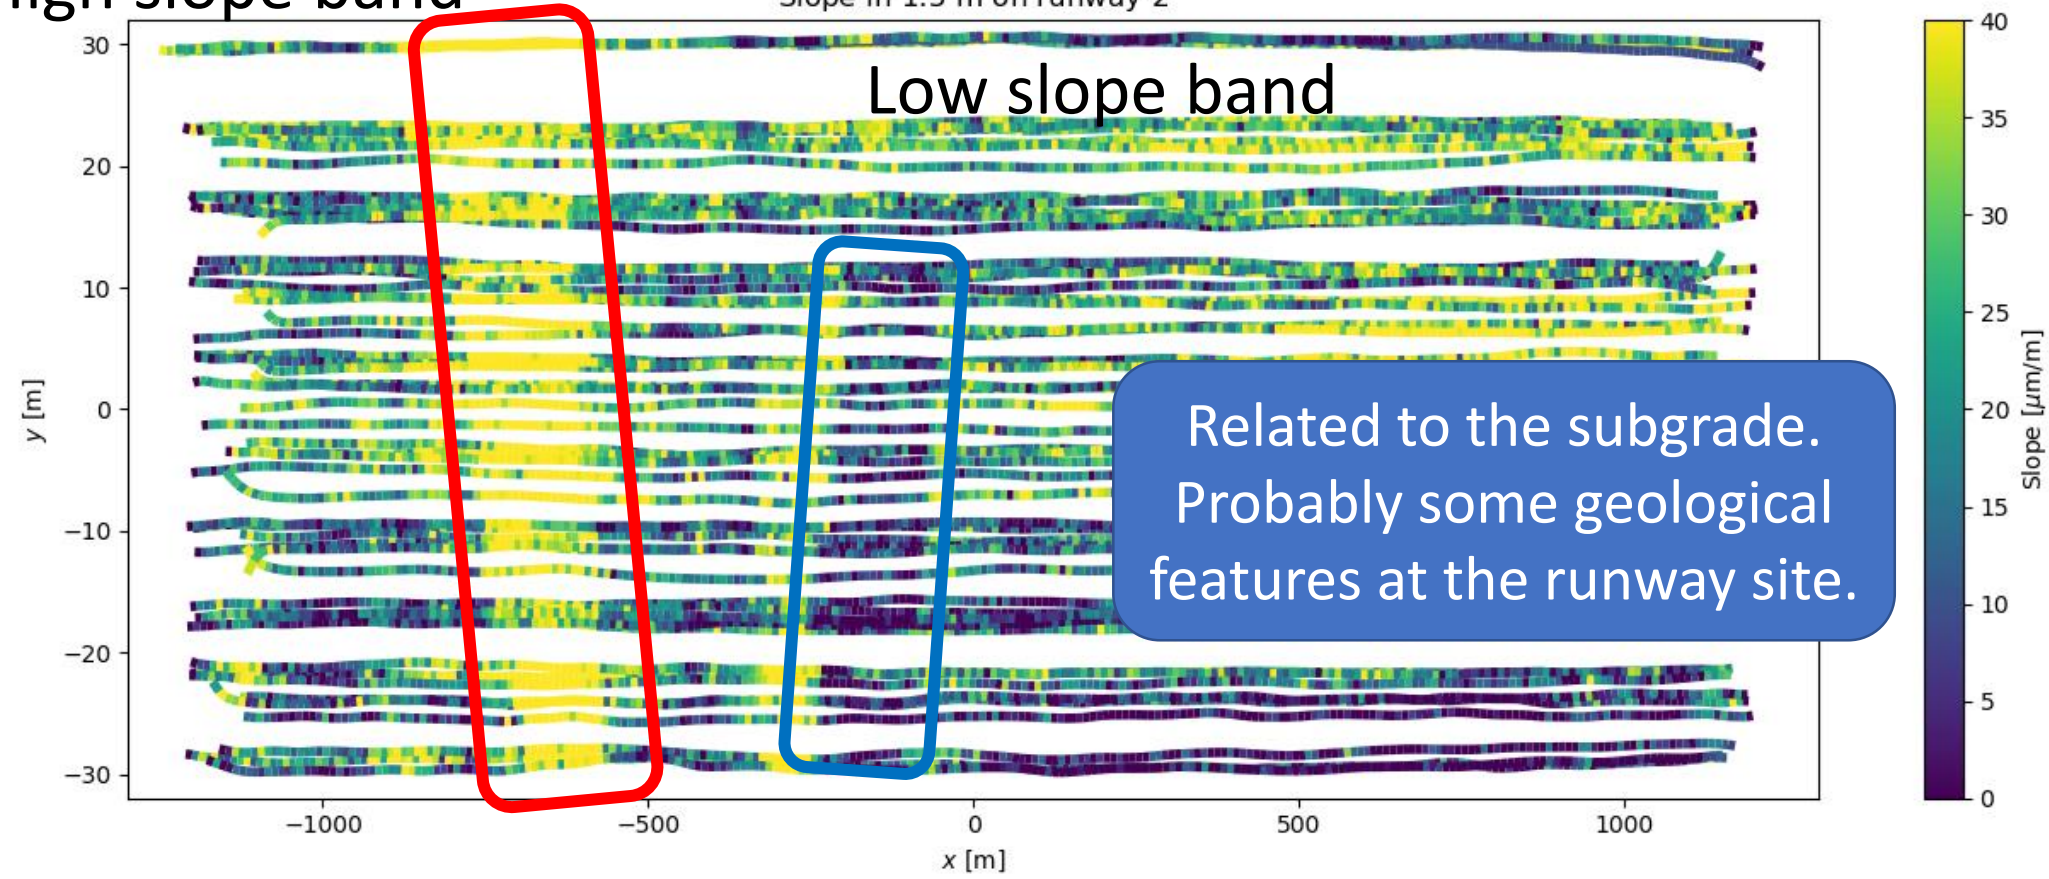
Slope in 1.5 m on runway 2

Low slope band

Related to the subgrade.
Probably some geological
features at the runway site.

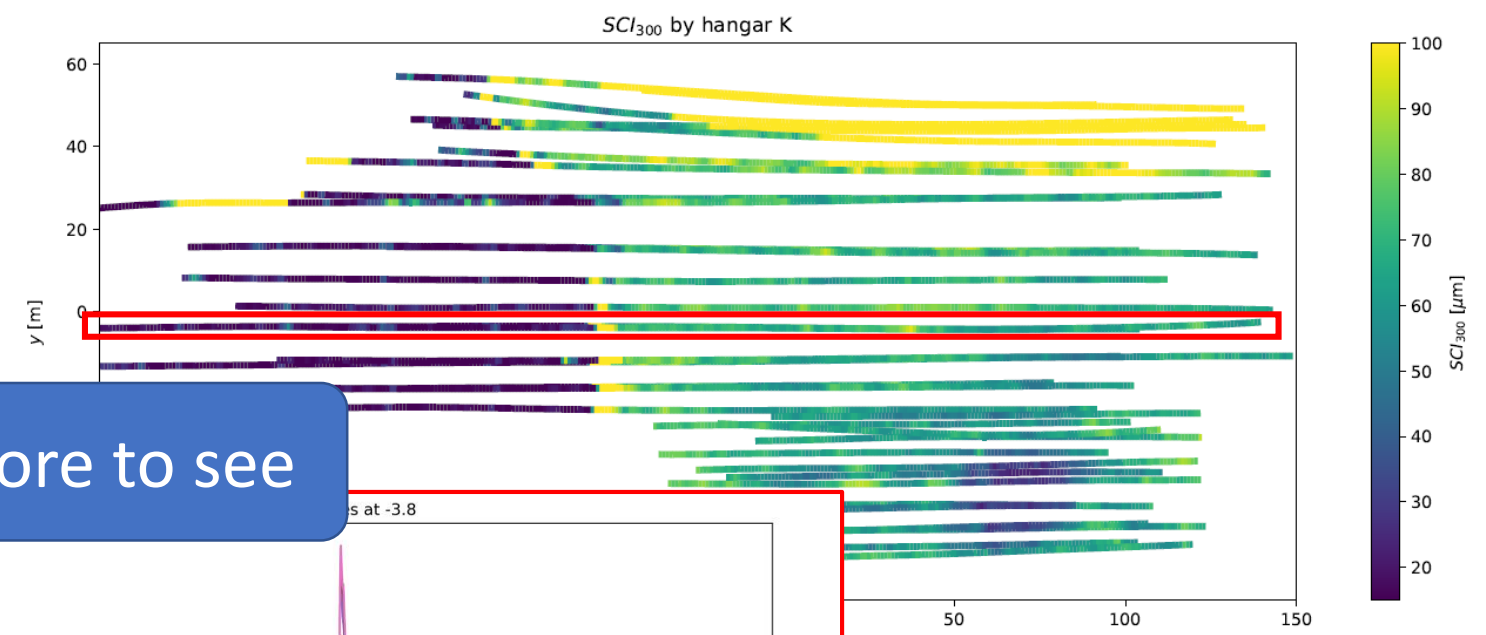
SCI300 at parking lot

- New and old pavements are clearly visible
- New problems might be developing near edge of new pavement

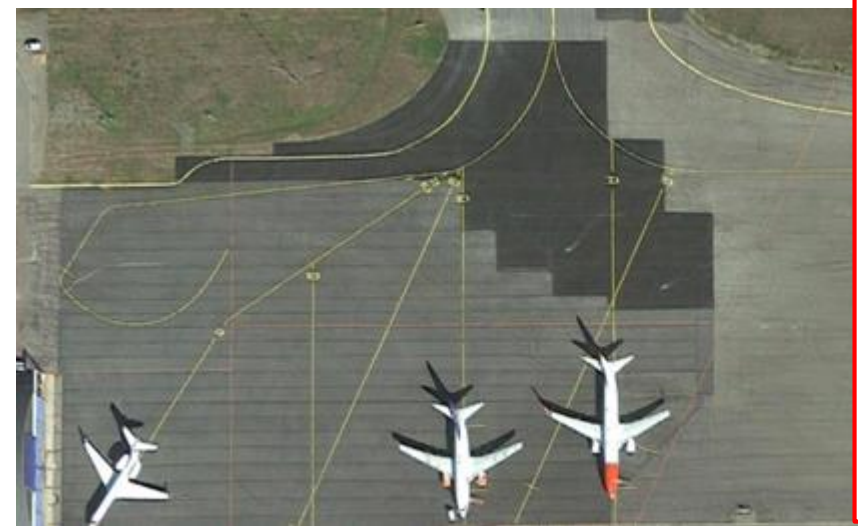
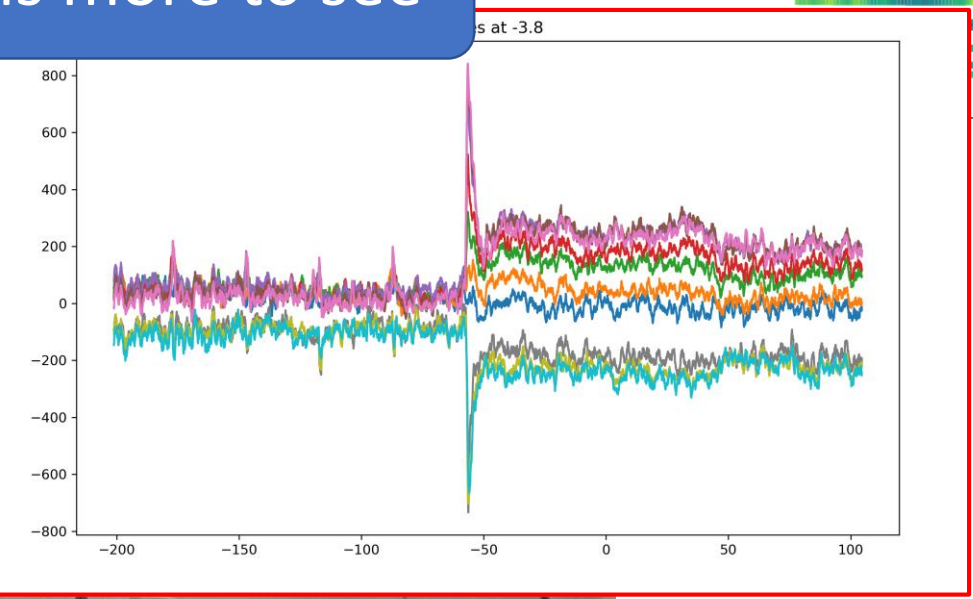
SCI300 at parking lot

Challenging conditions:

- Designed for airplane loads
- Concrete plates are covered with an asphalt layer

But still we are able to detect the joint movement

Clear joint signatures

Possible due to high accuracy in short reporting intervals

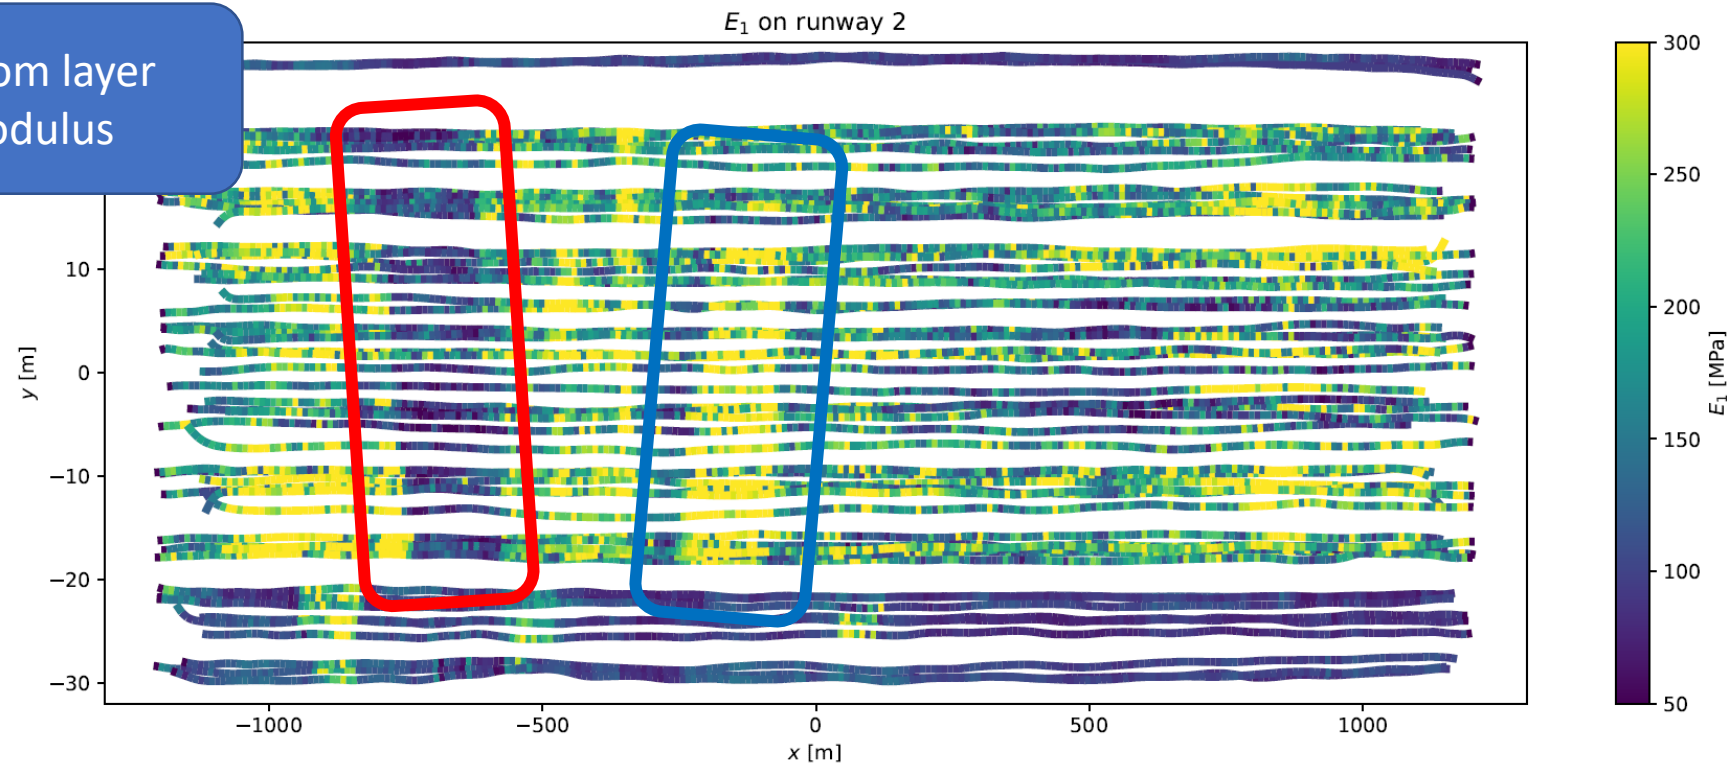
Back-calculation on runway 2

- Three layer model with layer thicknesses $h_3 = 25 \text{ cm}$, $h_2 = 30 \text{ cm}$, $h_1 = \infty$

Bottom layer modulus

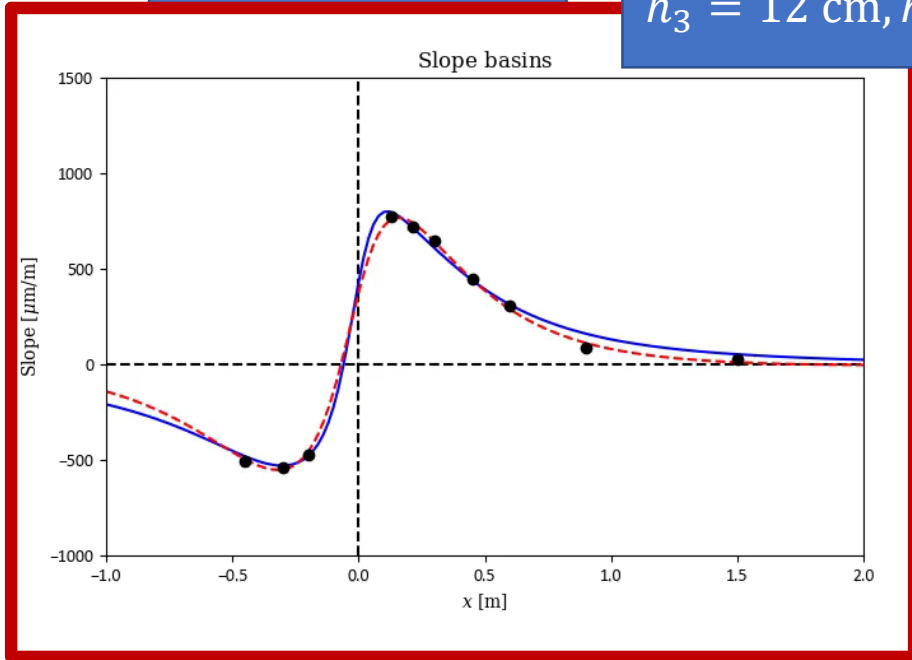
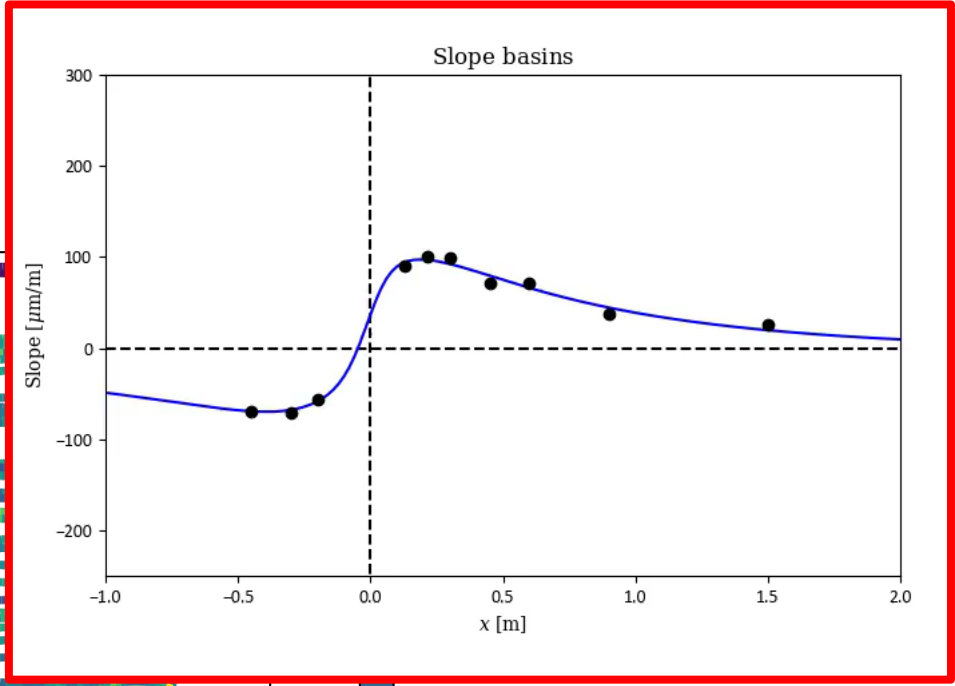
Back-calculation on runway 2

$h_3 = 12 \text{ cm}, h_2 = 30 \text{ cm}, h_1 = 100 \text{ cm}$
